Cedar Area Fire & Rescue Station Evaluation

Completed By: Chief Doornbos

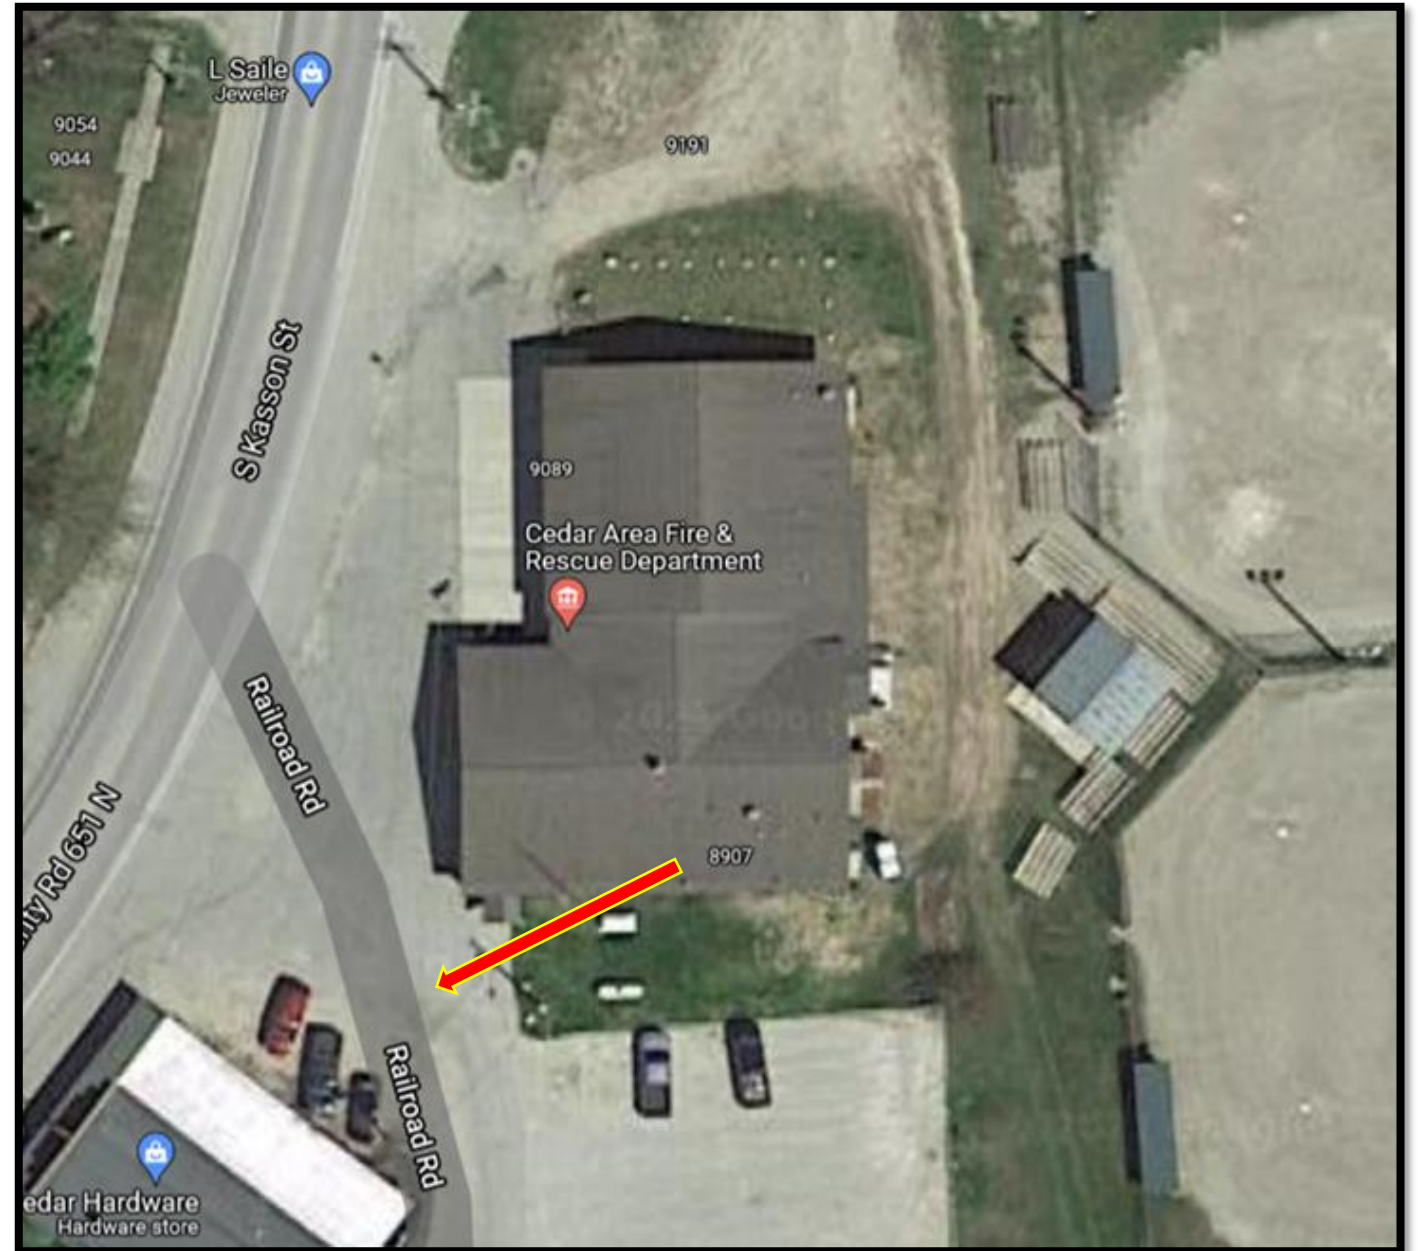
-Exterior-

- A major hazard for our building is the roadway that runs between the hardware and the corner of our building. Numerous instances of close calls have resulted in the orange barrels that you may see at the corner of our building. As we pull out from the apparatus bay we cannot see vehicles coming down Railroad and they cannot see us. This is an issue that we are working on with the road commission.

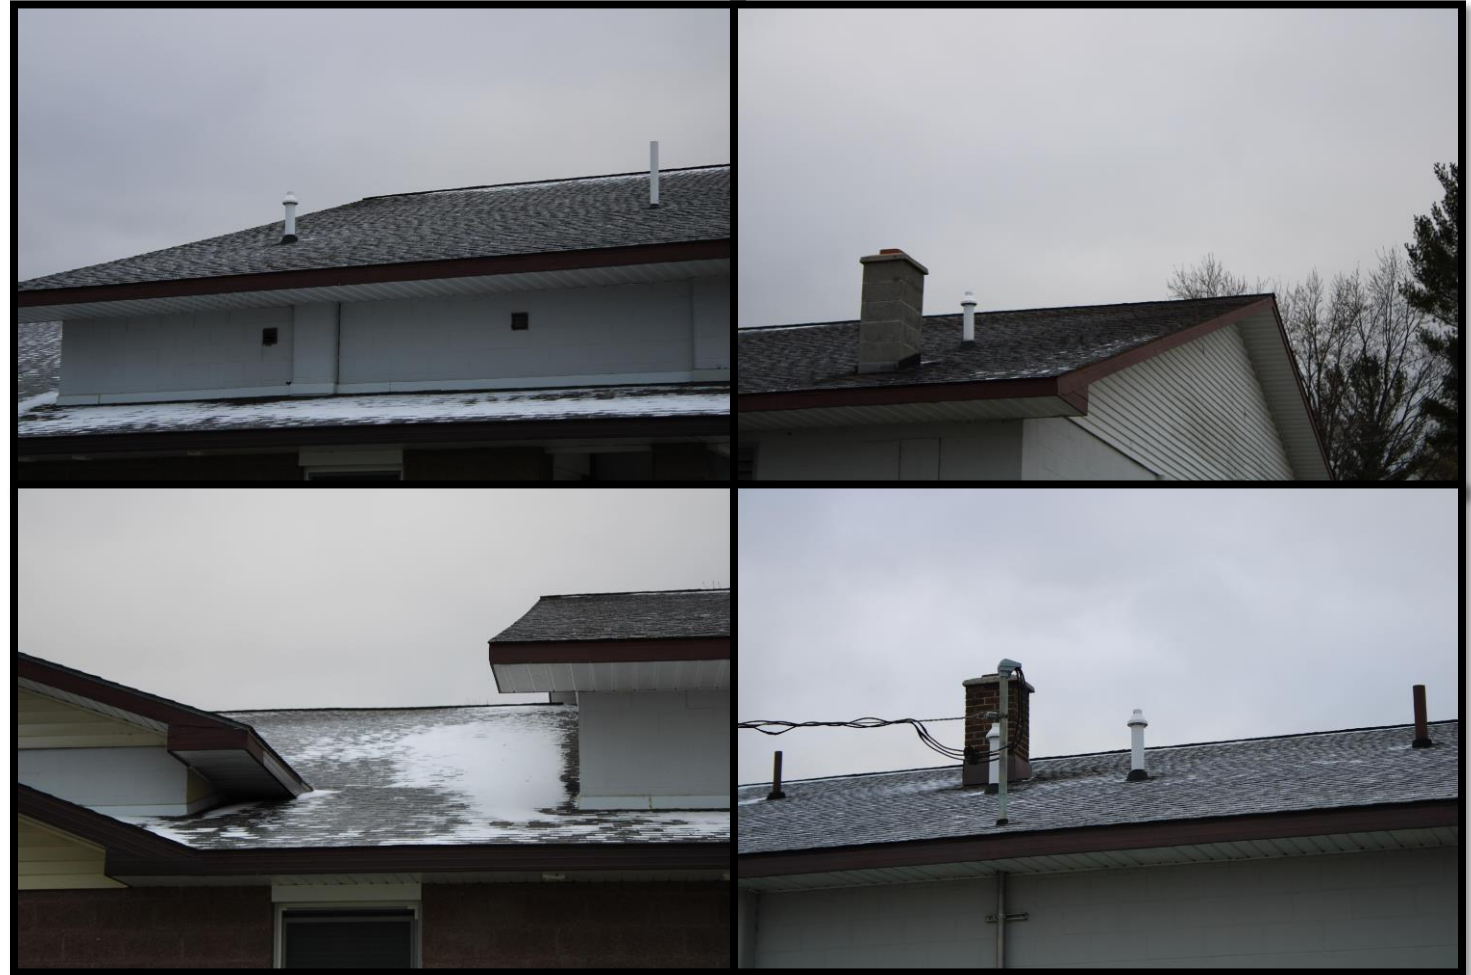
-Roof-

- The roof has areas that appear to be worn and in need of repair in the near future. There are apparent leaks in the rear of the building into the new crew quarters and along the wall near the dayroom door.
- See attached for quotes.

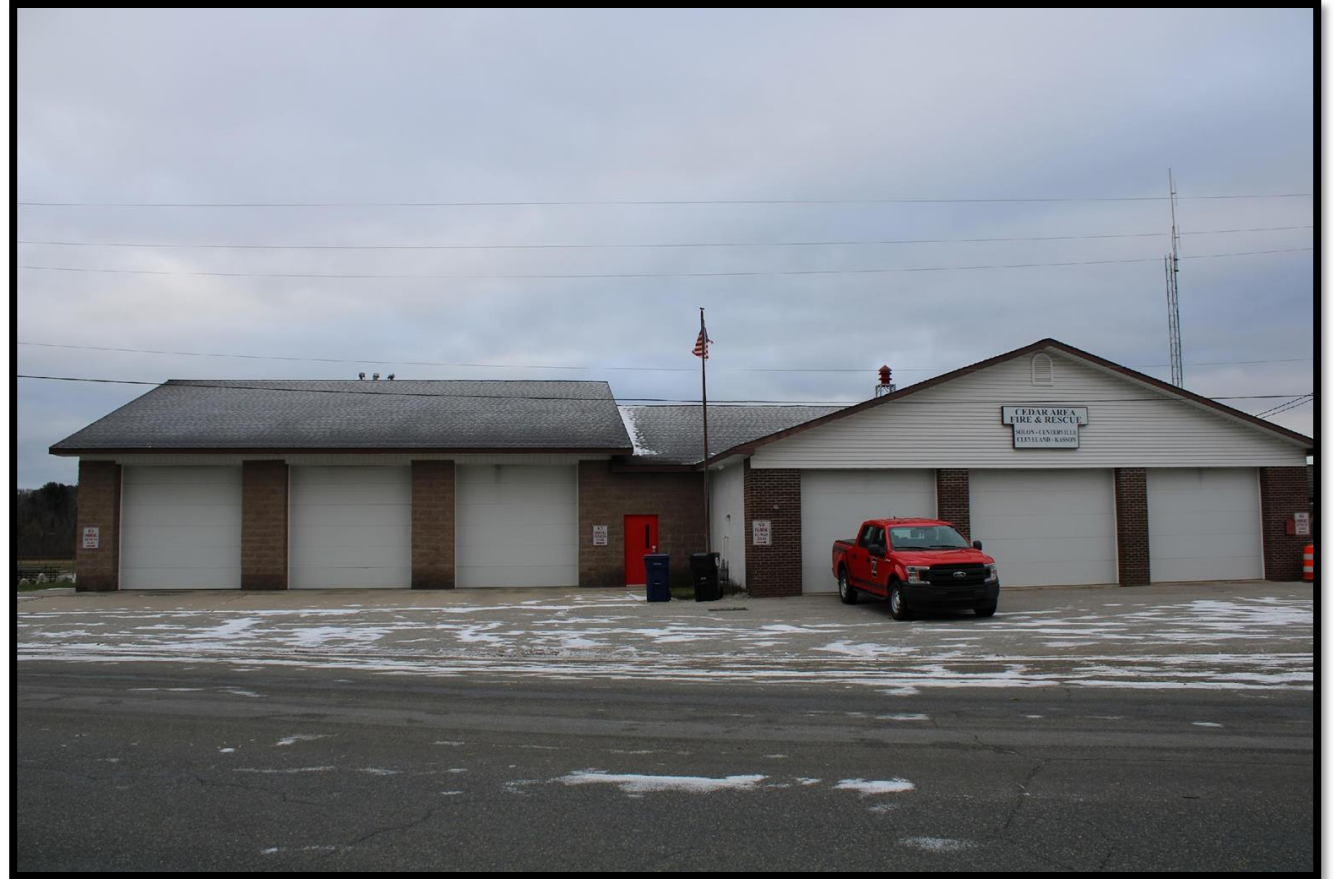
-Front of the Building-

- Generally, the front of the building does not need any major structural issues addressed.
- The garage doors are nearing the end of their service life. They are becoming hard to find parts / panels for and are becoming in need of service more frequently.

4. Garage Doors. Earlier this year we had our garage doors serviced for the first time in many years. This included weather strip replacement and door adjustment. Even with this service our doors are nearing the end of their practical service life. By replacing the doors with new, we will be able to add glass panels that will increase the ambient light in the apparatus rooms and not require us to have as many lights on during the daylight hours, again reducing energy cost. The second benefit will be the ability to service them should a breakdown occur. Our current equipment is not easily serviced and according to the service company our door panels are becoming more difficult to acquire. This may lead to mismatched panels and doors that will not present a professional appearance to the vehicles that pass by.

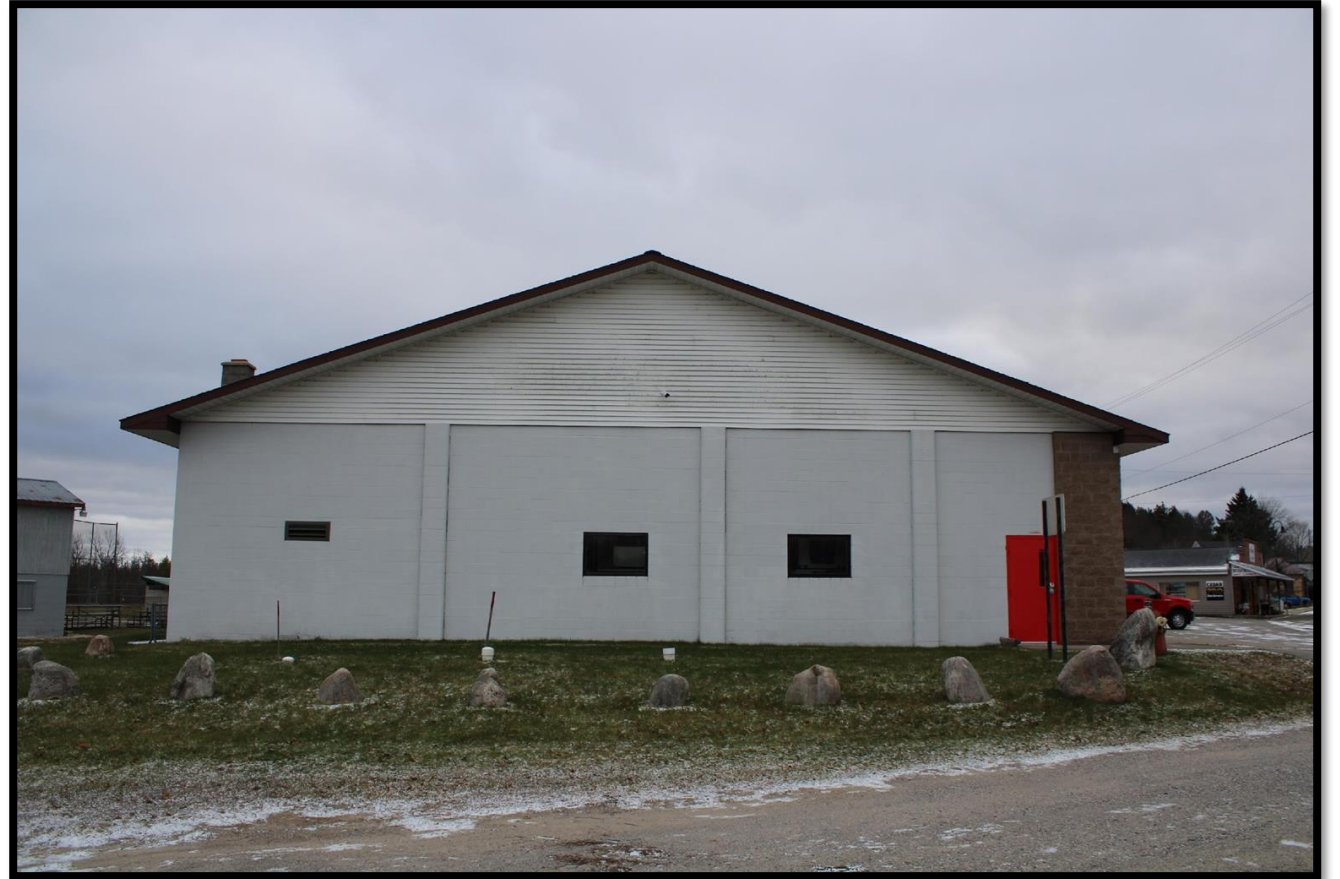
-North Side-

- Paint is thinning and in need of work.

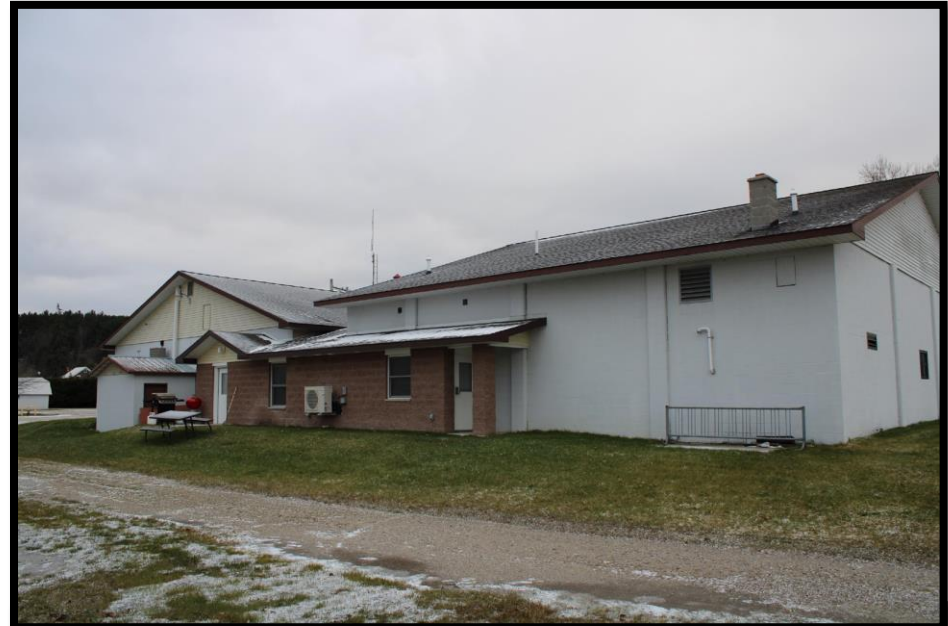
-East Side-

- Paint is thinning and in need of work.

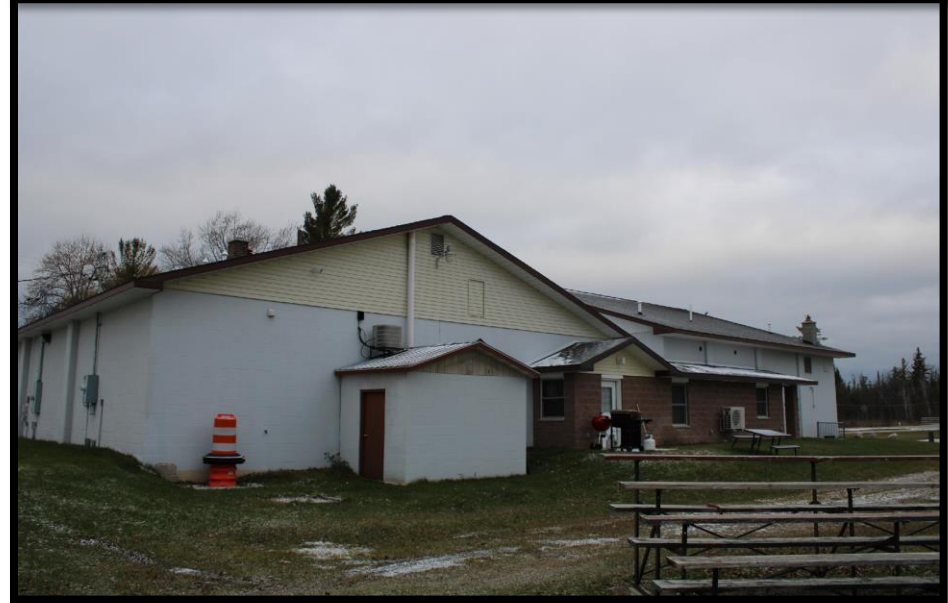
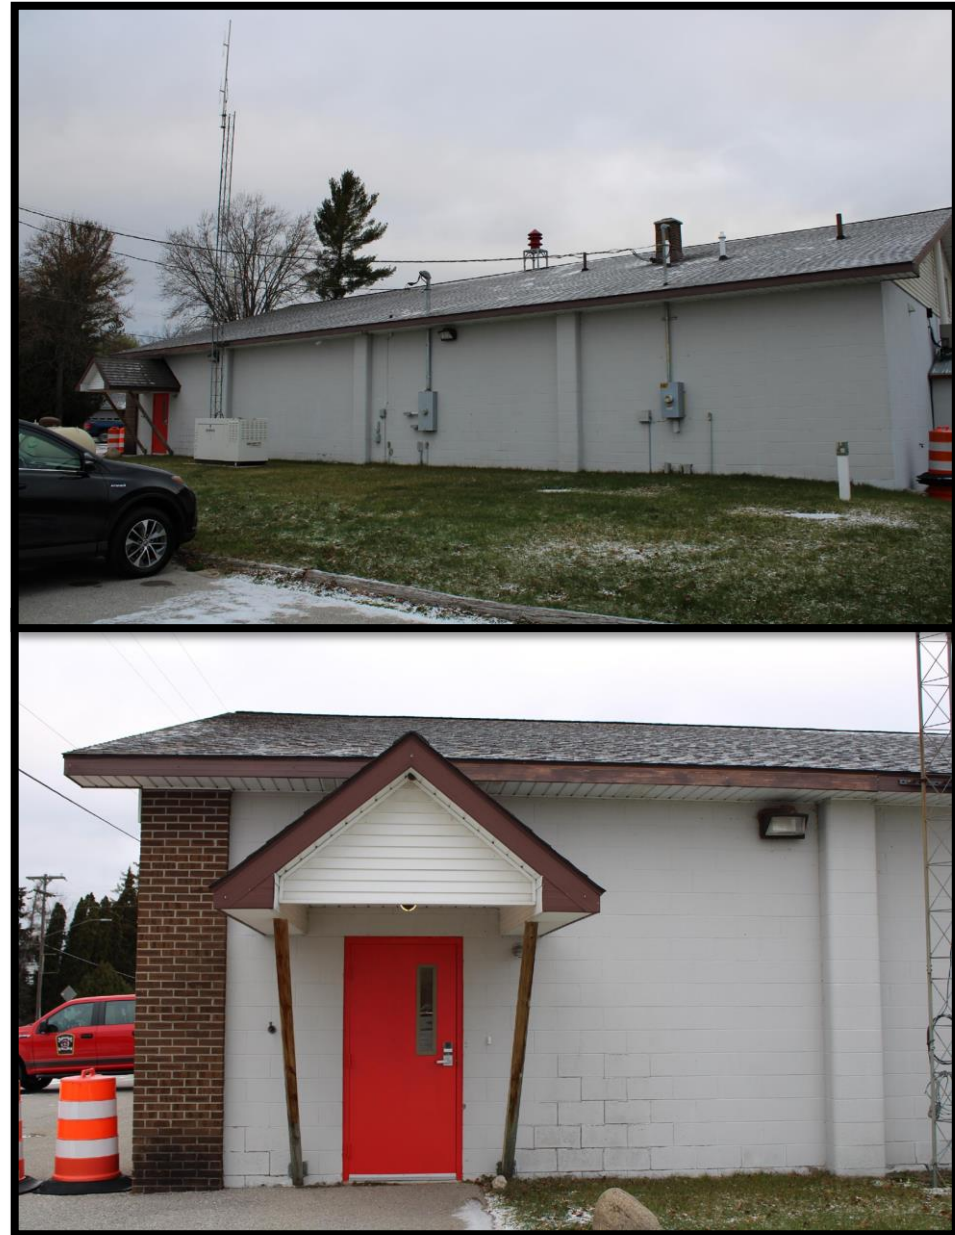
-South Side-

- Paint is thinning and in need of work.
- Signage and lighting should be addressed at the entrance door.

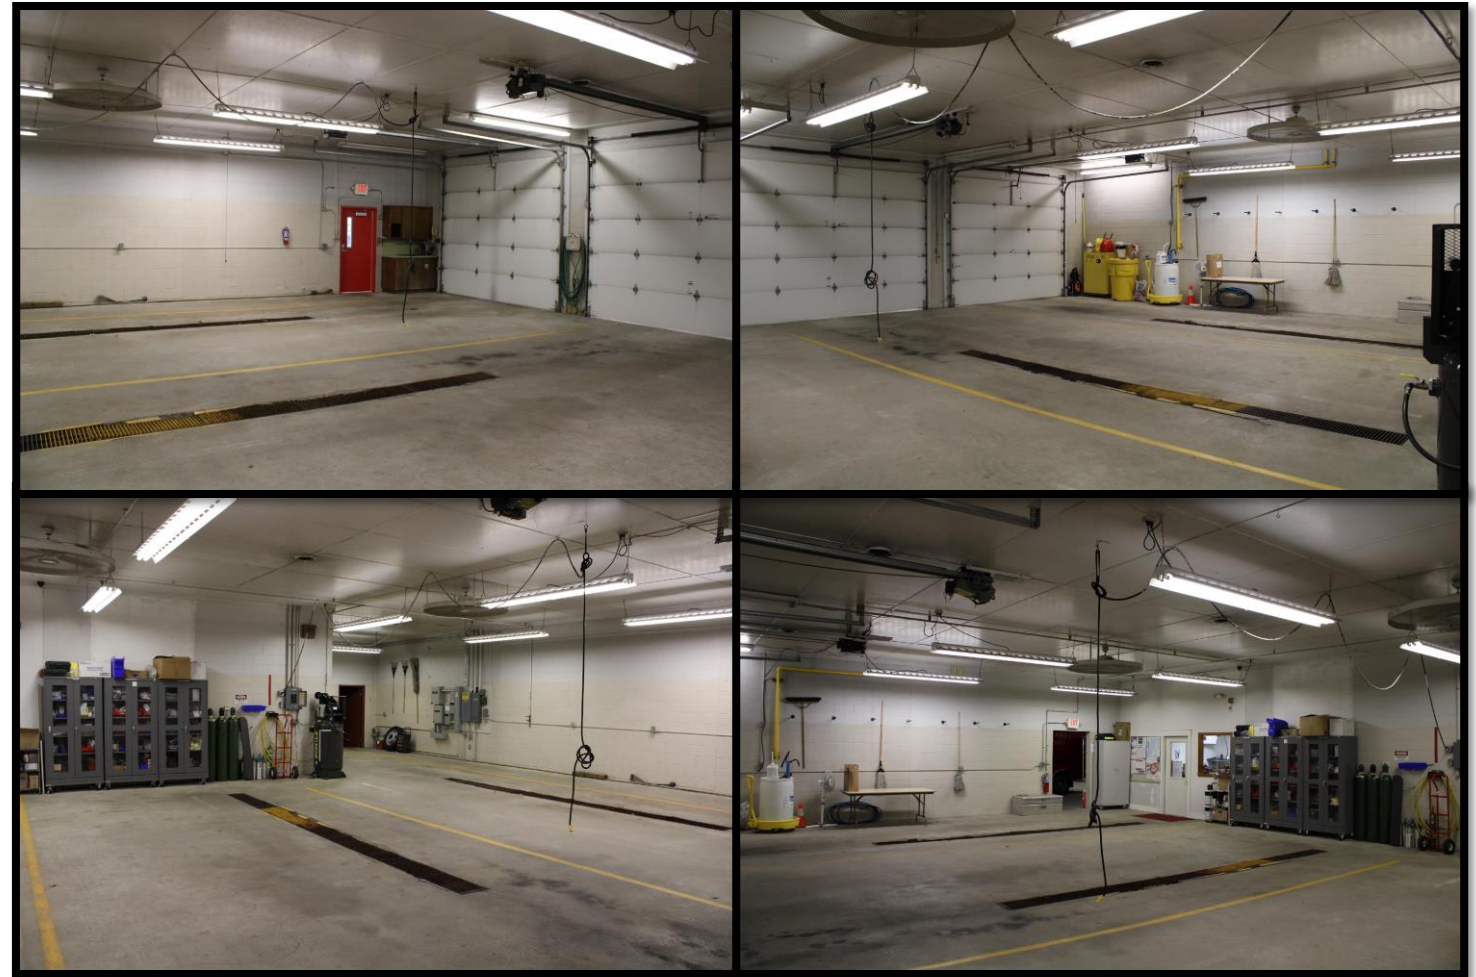
-South Apparatus Bay-

- Lacks ambient lighting.
- Lighting fixtures are out of date and not energy efficient.
- Some electrical connections for apparatus are extension cords and not appropriately mounted.
- Paint on walls and ceiling should be addressed.
- Floors are in disrepair and not sealed to prevent permeation.

1. Our top priority is the floors in the apparatus rooms. The drains do not have bottoms and the area around the grating is hazardous for our members and visitors to the station. This project was only bid on by one company, Spence Brothers. Other companies looked at the job but were not willing to offer any pricing. The official proposal for the floor repair will be attached to this report.

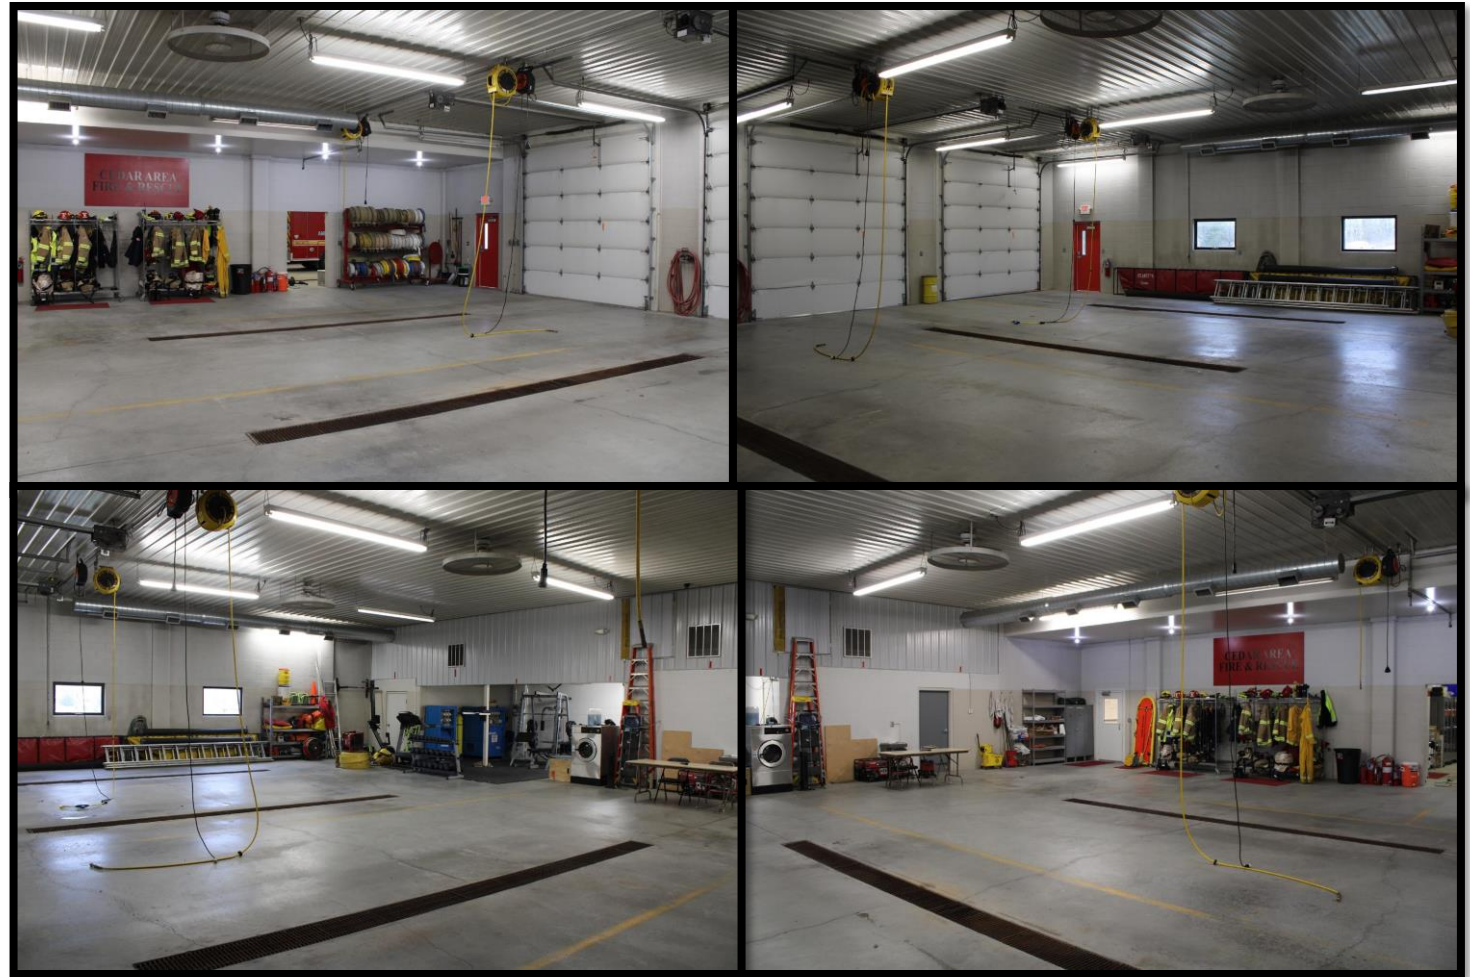
-North Apparatus Bay-

- Lacks ambient lighting.
- Lighting fixtures are out of date and not energy efficient.
- Some electrical connections for apparatus are easily overloaded and GFI/Breakers trip often.
- Paint on walls and ceiling should be addressed.
- Floors are in disrepair and not sealed to prevent permeation.

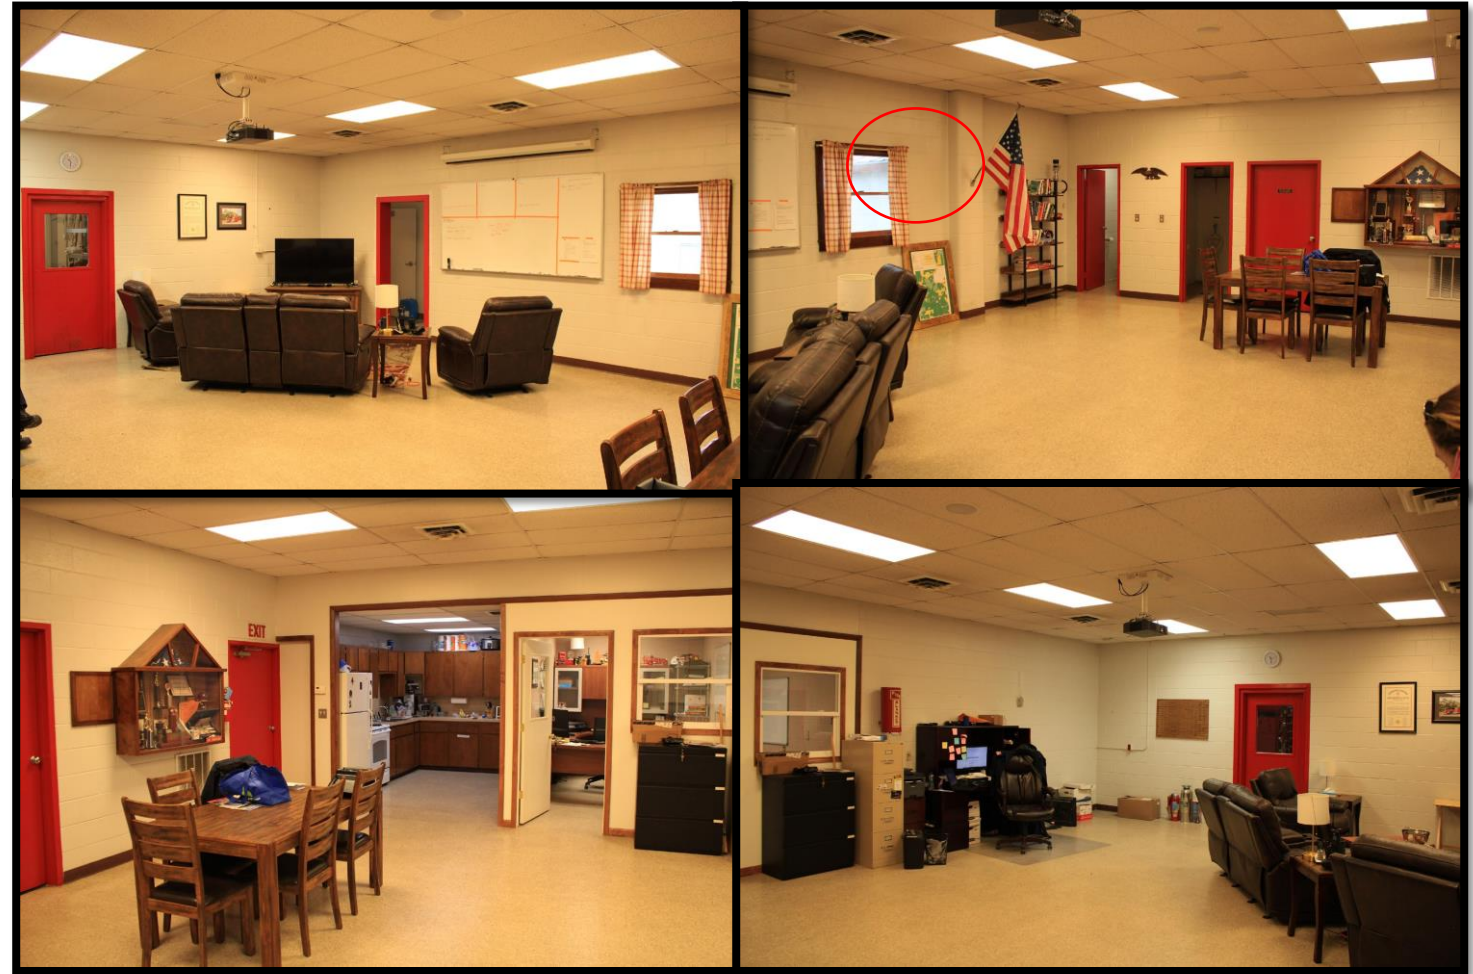
-Dayroom & Kitchen-

- Lacks ambient lighting.
- Lighting fixtures are out of date and not energy efficient.
- Some electrical connections are extension cords and not appropriately mounted.
- Paint on walls and ceiling should be addressed.
- Floors need updating
- Kitchen should be updated and outfitted with energy efficient appliances.
- Used for multiple things including dining room, day room, offices, training room, meeting room.
- Some joints in the exterior wall show light through them as the mortar joints have cracked.
- Bathrooms off this room do not meet ADA requirements.

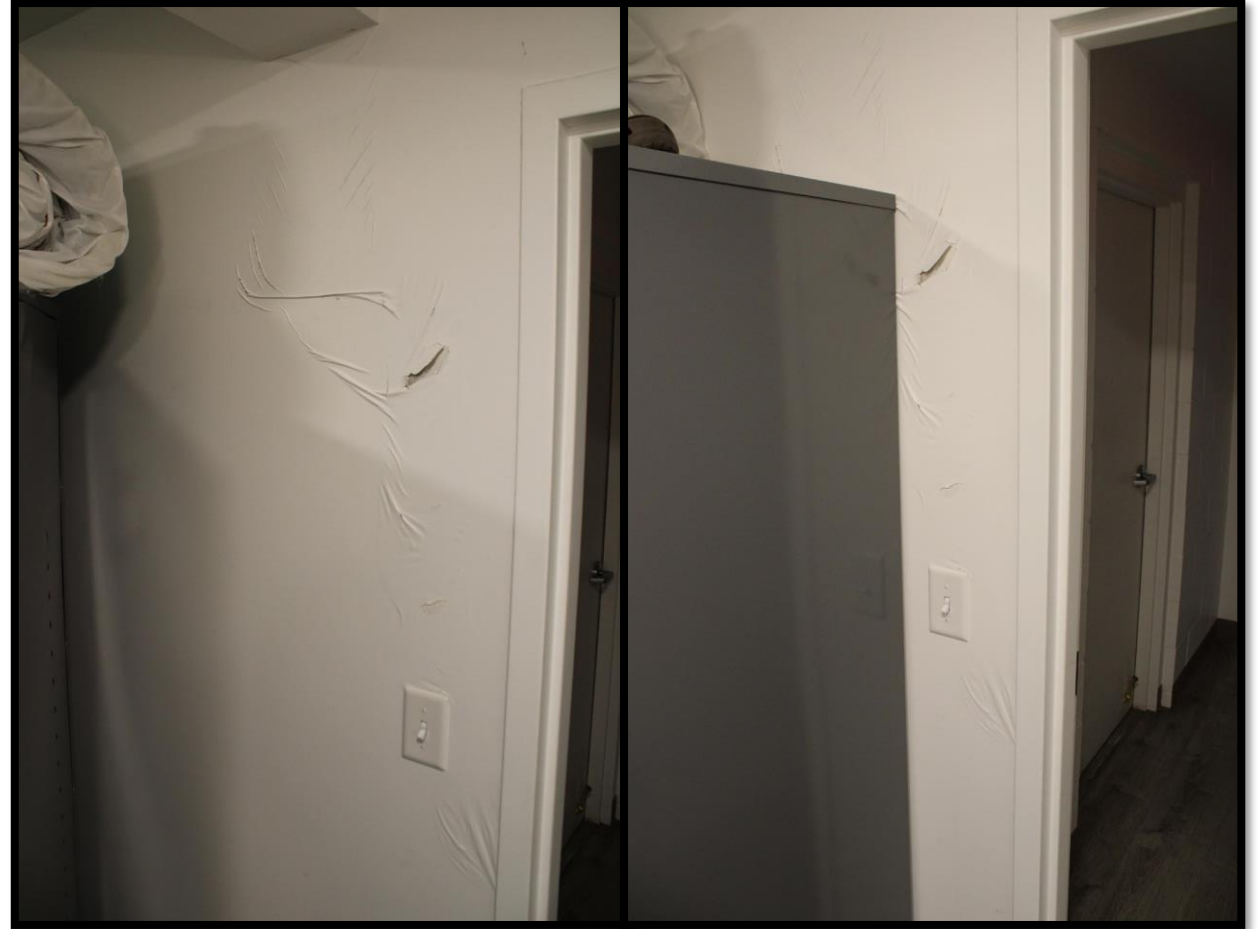
-Hallway Addition-

- Apparent paint separating from the drywall in multiple areas from roof leaks.
- No ability to add a third persons' sleeping quarters.
- No attic access ability.

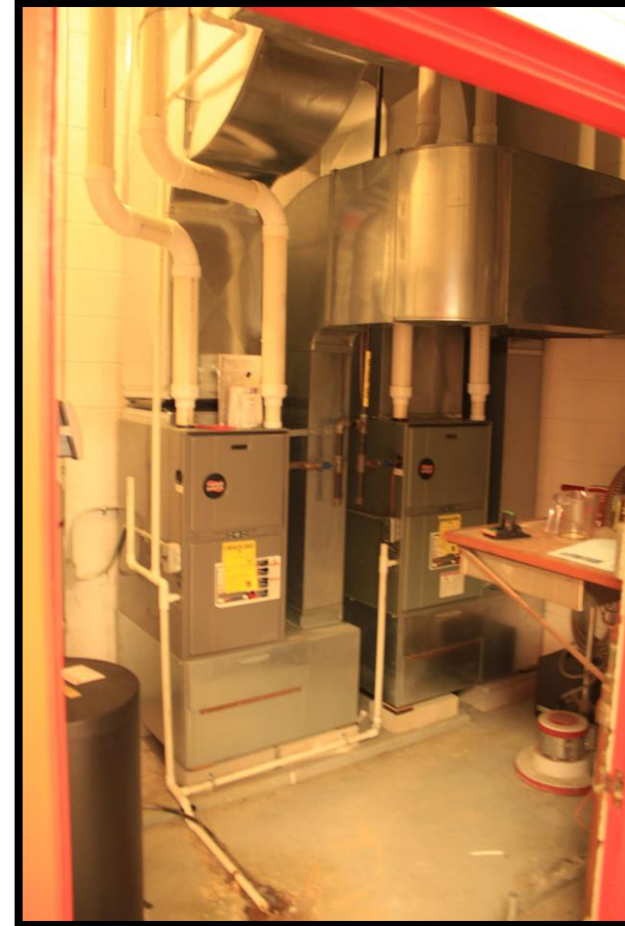
-HVAC-

- HVAC appears to all be in good working condition.
- This equipment is under a yearly service contract to assure its continued operation.

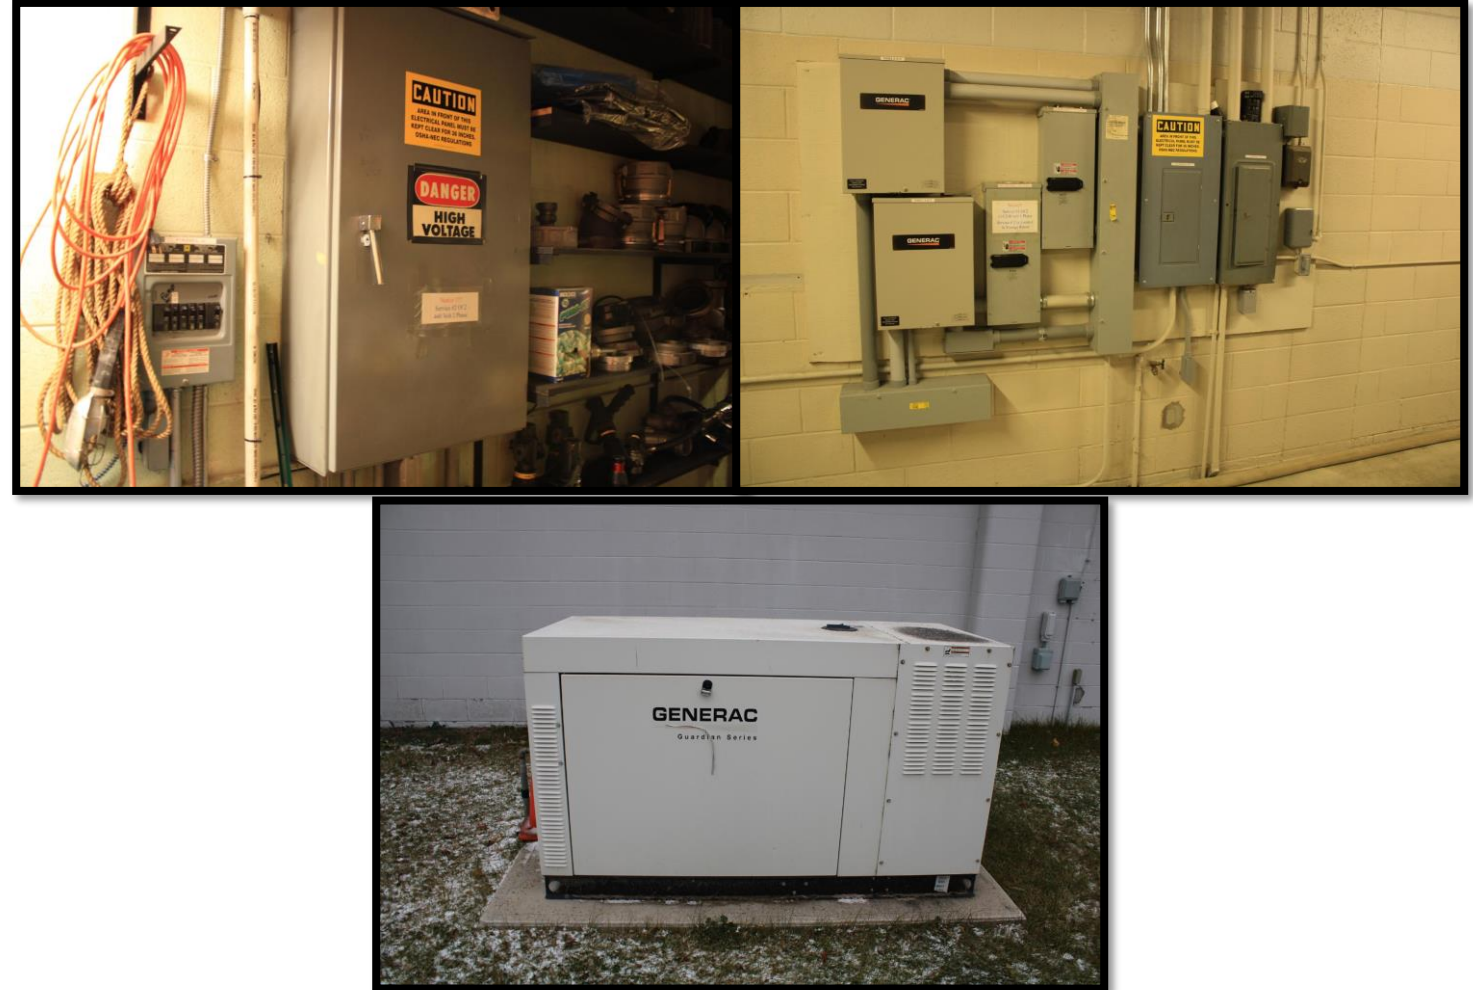
-Electrical-

- Unknown overall electrical condition. With all the renovations the building has had in its lifetime it's difficult to assess without a professional.
- Building generator is in good working condition.

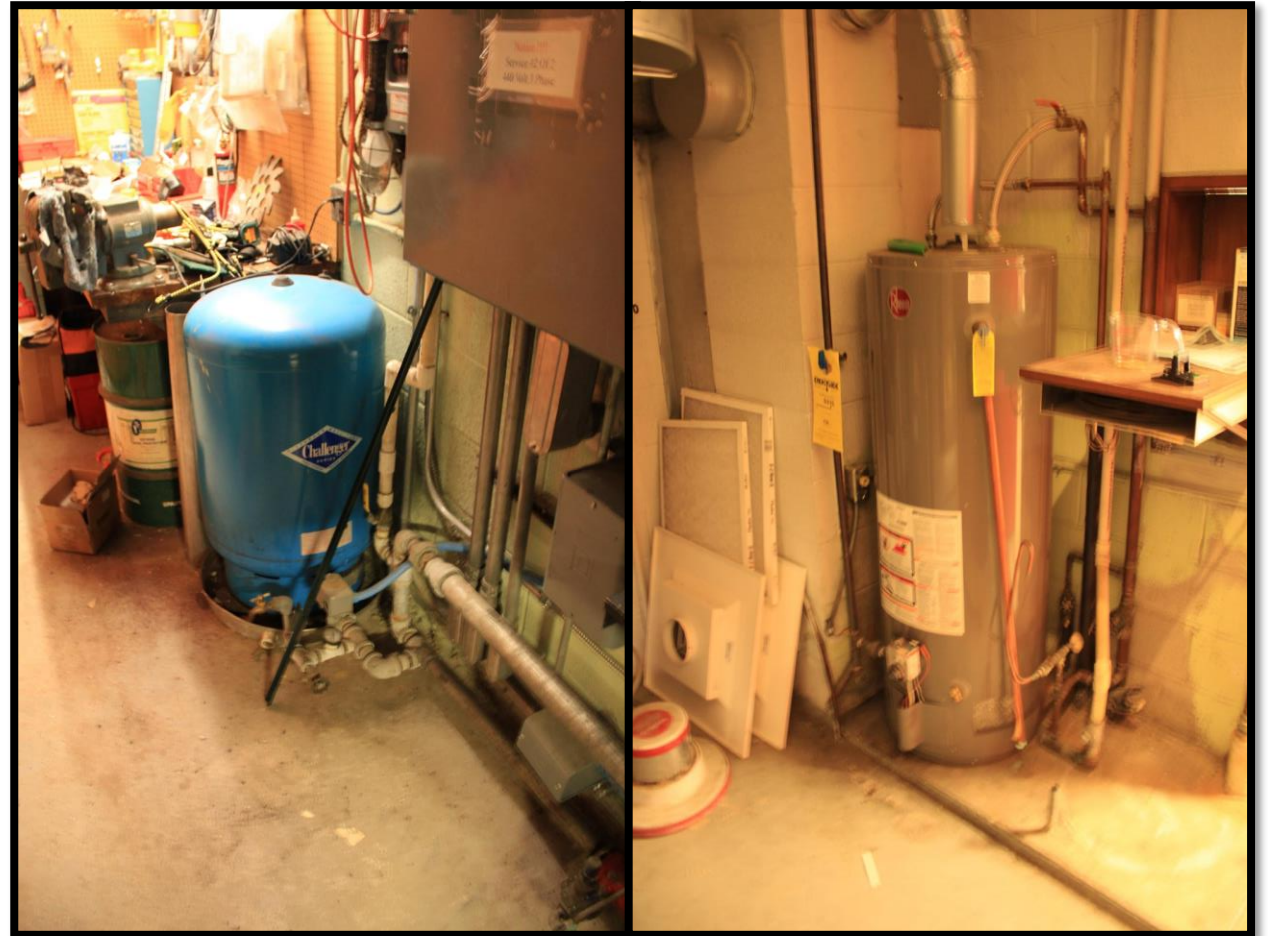
-Plumbing-

- Our building is on a holding tank for all water used.
- Unknown overall plumbing condition. With all the renovations the building has had in its lifetime it's difficult to assess without a professional.
